[Docket No. FAA-2023-1055; Project Identifier AD-2023-00583-T; Amendment 39-22445; AD 2023-10-09]

Airworthiness Directives; The Boeing Company Airplanes

SUMMARY: The FAA is adopting a new airworthiness directive (AD) for all The Boeing Company Model 787-8, 787-9, and 787-10 airplanes. This AD was prompted by reports of damaged decompression panels from operators. This AD requires repetitive inspections for damaged fastener holes on the vertical and bottom edges of the inward and outward blowing decompression panels installed on the forward and aft cargo compartment vertical sidewall linings and applicable on-condition actions. The FAA is issuing this AD to address the unsafe condition on these products.

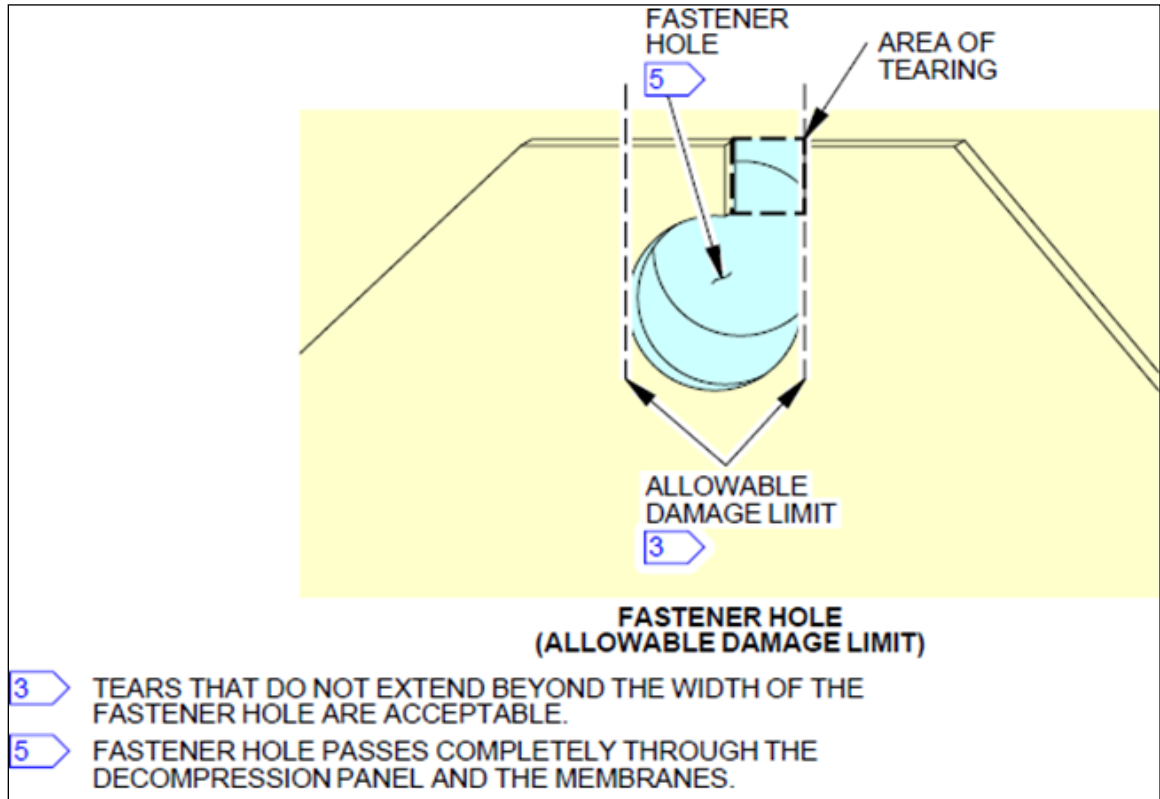
Figure 1 to paragraph (g)(3)(i) – Allowable damage not extending beyond fastener hole width

(i) If the damage is on the fastener hole, the damage must not extend beyond the width of the fastener hole. Refer to figure 1 to paragraph (g)(3)(i) of this AD. Where figure 1 to paragraph (g)(3)(i) of this AD refers to tears or tearing, this includes all types of damage as defined in paragraph (g)(2) of this AD.

(2) If, during any inspection required by paragraph (h) of this AD, any damaged fastener hole is found and the decompression panel is deemed not serviceable, before further flight, replace the panel with a serviceable panel, except as provided by paragraph (j) of this AD. Replacement must be done in accordance with the operator's maintenance or inspection program, as applicable. Make sure the panel fastener holes are not folded back when installing the decompression panel.

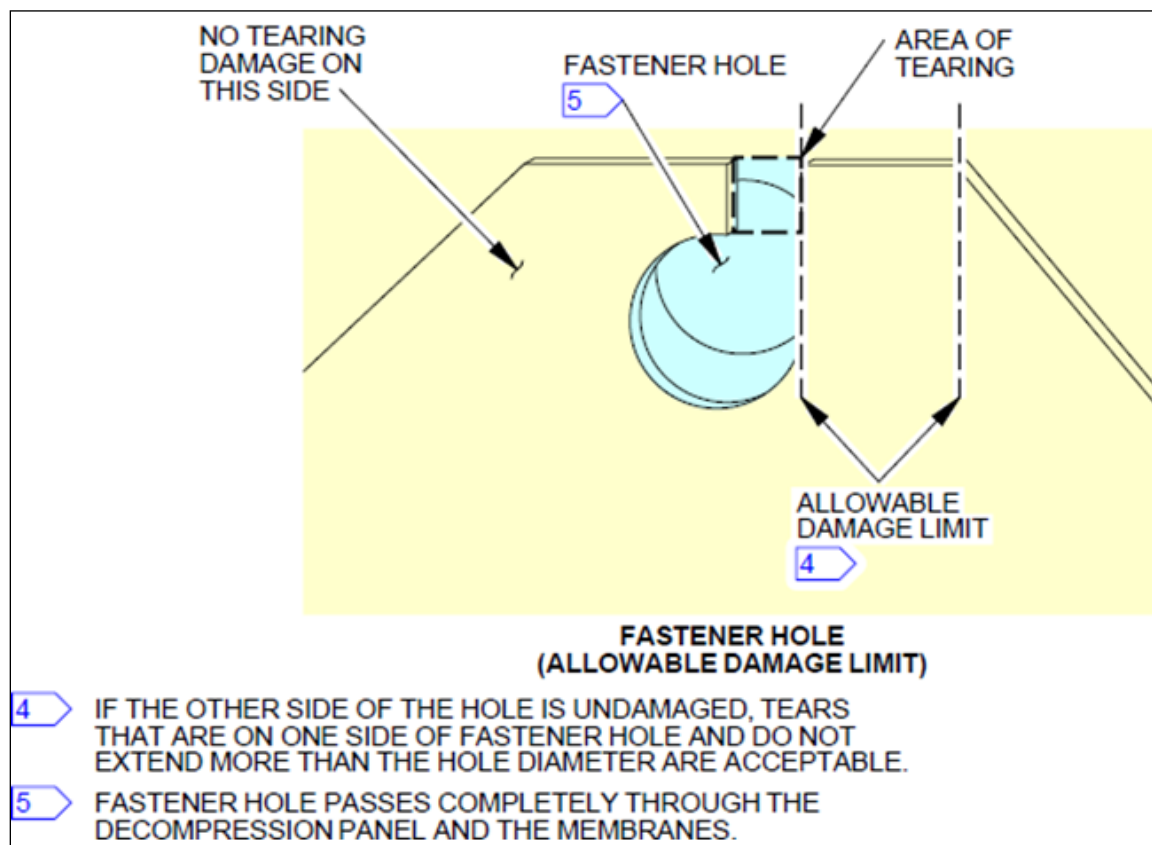
Figure 2 to paragraph (g)(3)(ii) – Allowable damage not extending more than fastener hole diameter

(ii) If the damage is on one side of the fastener hole and the other side of the fastener hole has no damage, the damage must not extend more than the diameter of the fastener hole. Refer to figure 2 to paragraph (g)(3)(ii) of this AD. Where figure 2 to paragraph (g)(3)(ii) of this AD refers to tears, tearing, or tearing damage, this includes all types of damage as defined in paragraph (g)(2) of this AD.
